Urban and Suburban Stream Restoration Structures

Examples, guidance, construction and long-term performance

3 Rivers Wet Weather Stream Restoration Symposium June 22, 2018

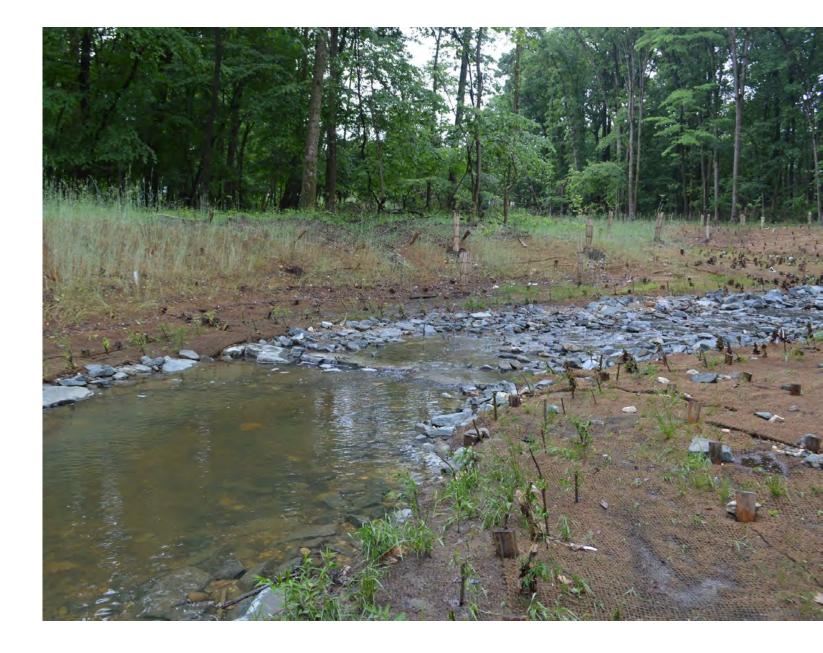
Constructed Riffle with downstream sill and floodplain bench

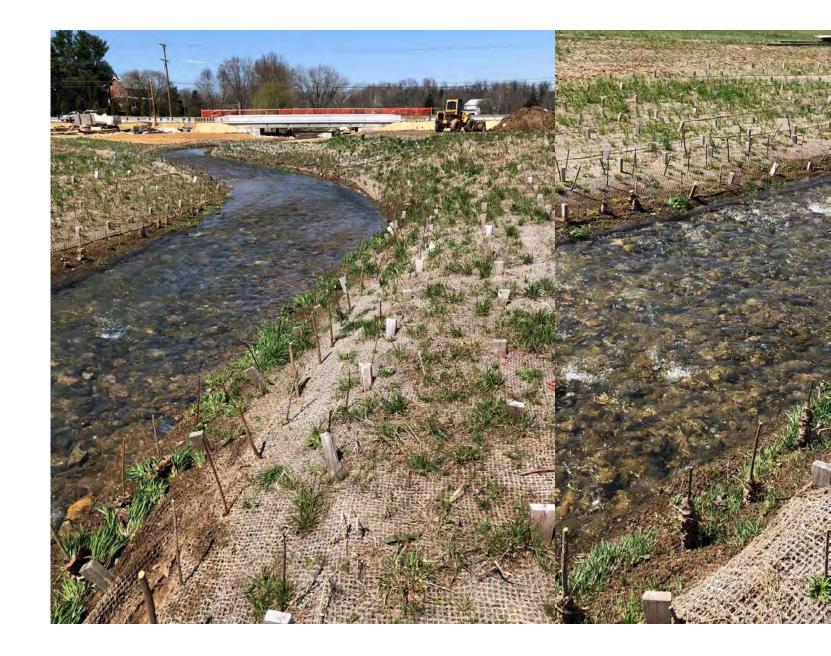
Constructed Riffles & Live Stakes at bridge replacement site

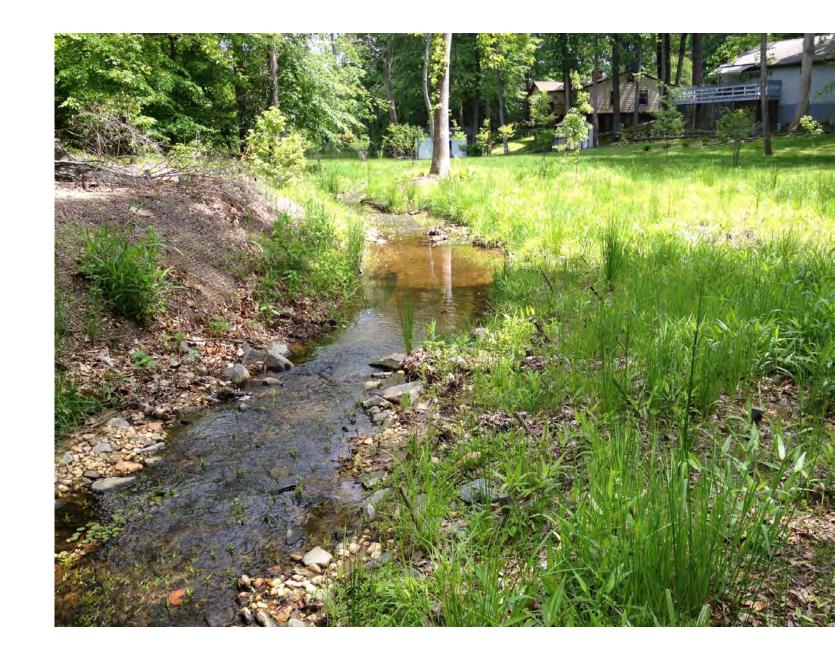
Constructed Riffles -Smaller Channel

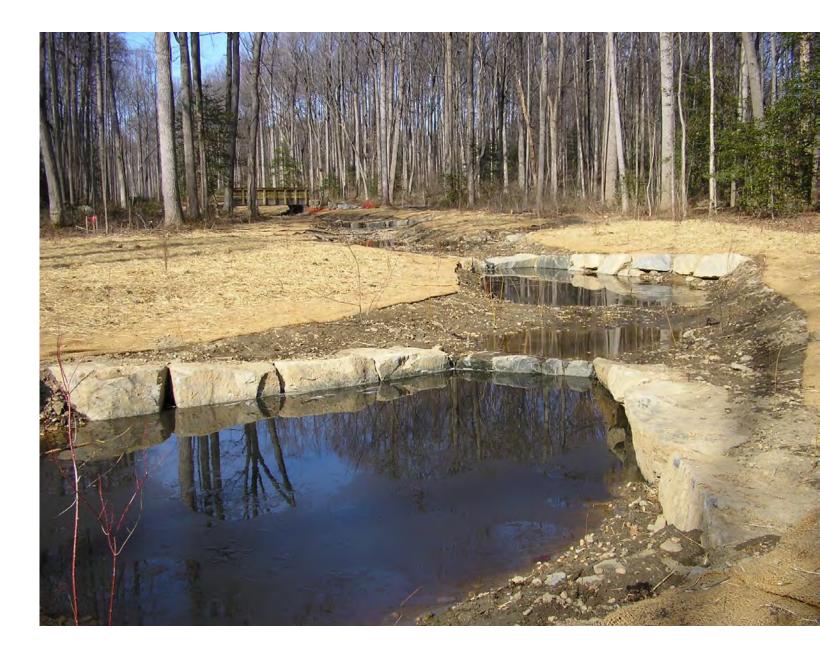
Cross Vane

- Imbricated rock
 structures
- Hardened grade
 control
- Converging and turning of flows
- Weir flow hydraulics
- Passive bank protection downstream
- Control of bed scour

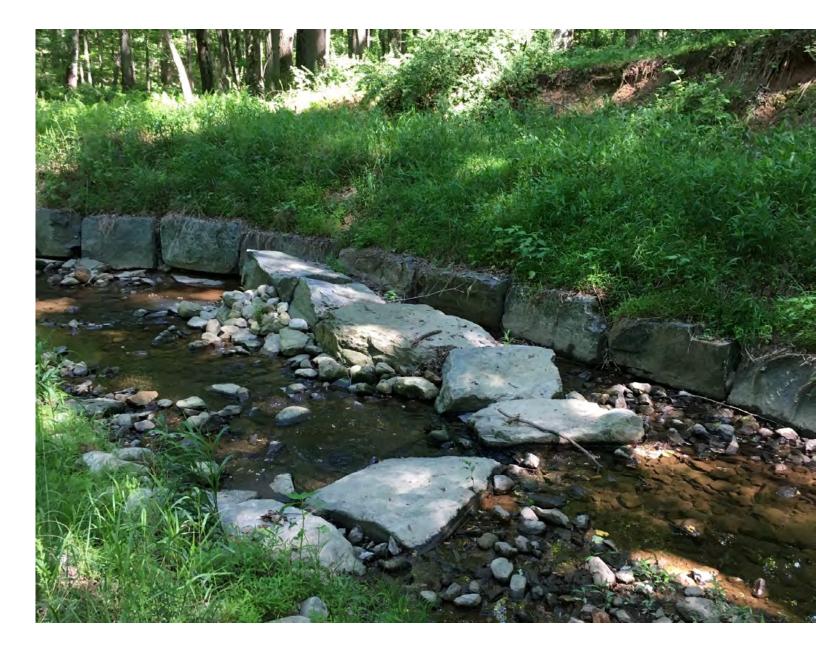
J-Hook, Rock Toe & Soil Lift Combination

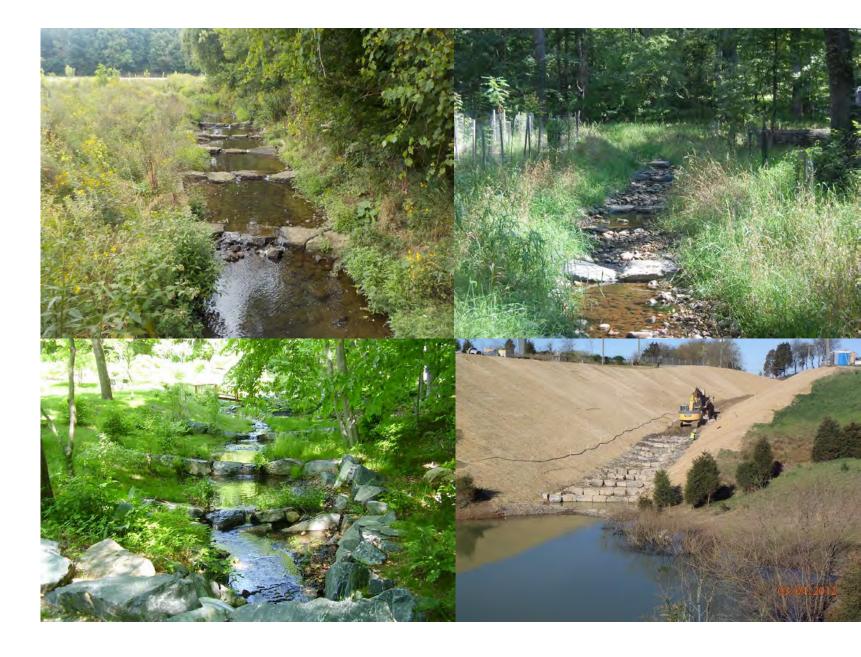
Rock Sills

- Provides hardened grade control without vane arm weir influences on channel flows
- Shaped for slight influence on flow directions
- Can provide control of bed scour
- Post-Construction
 - More prone to sedimentation
 - Fish passage blockage concerns

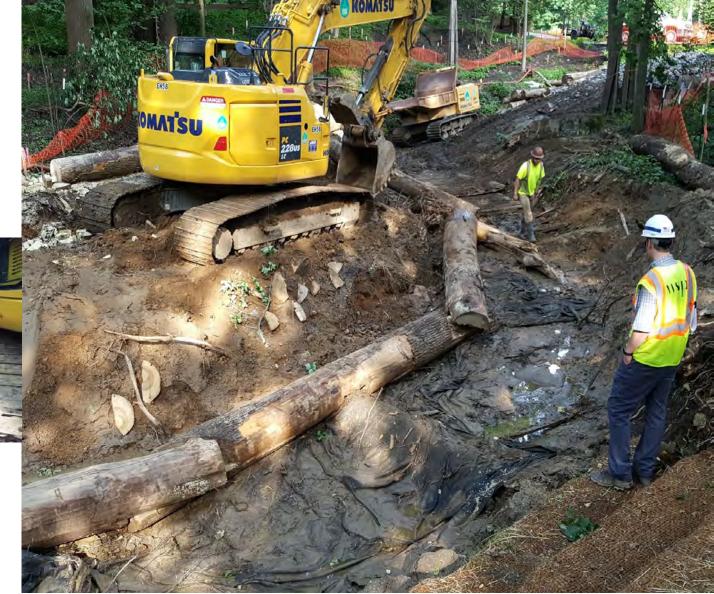
Log Toes During Construction

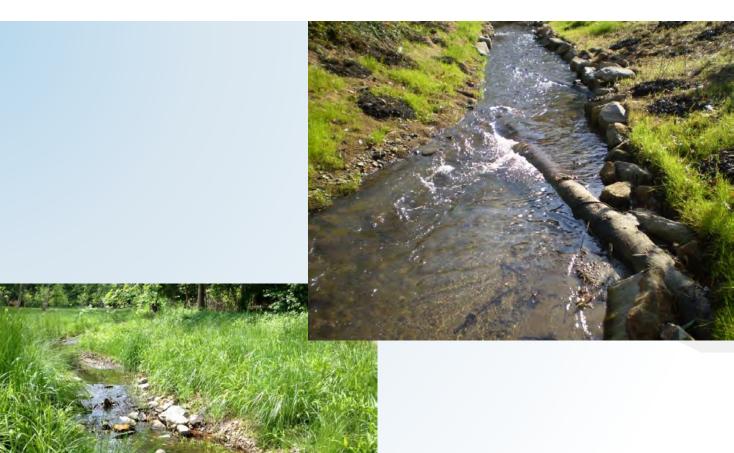
Log Vane

- Single arm
- Double arm

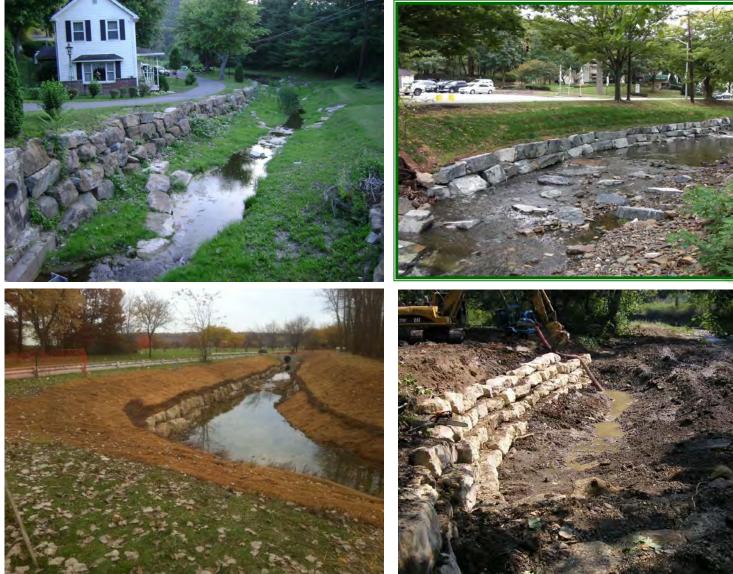
Imbricated Rock Wall & Rock Toe

- Used in confined channels
- Often used to protect infrastructure
- Can be combined with bank grading and/or soil lifts

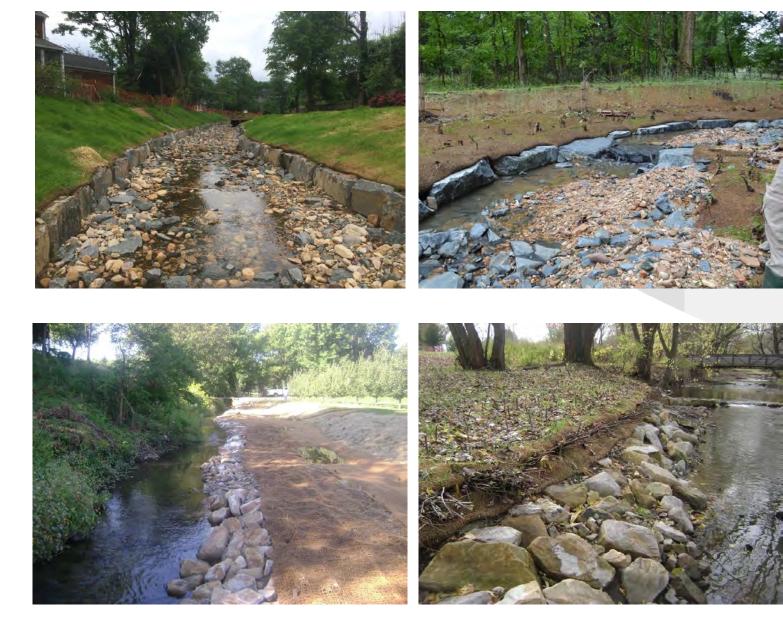
Rock Toe

- Hardened protection of banks in high stress areas
- Protection of utilities
- Hardened construction method for steep slope areas

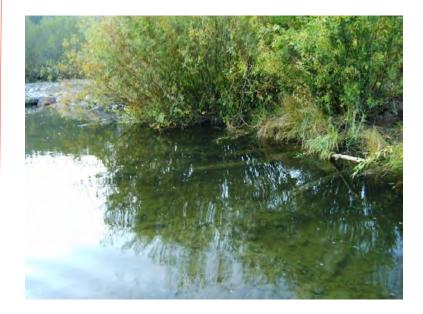
Toe Wood

- Construction of steep channel banks in exterior meander bends / pools
- Allows for construction of asymmetric pools
- Great habitat feature within pools
- Use of salvaged native materials from project site
- Cantilevering of logs provides scour resilience
- Bank roughness increases exterior pool scouring / sustainable pools

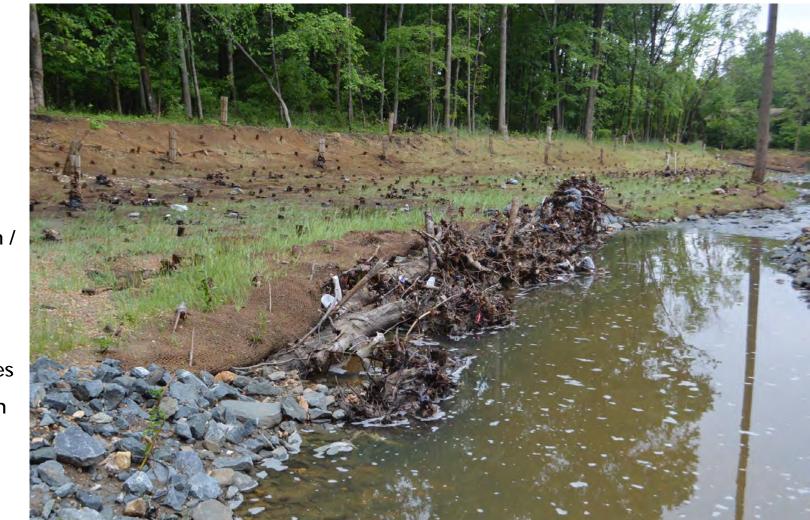
Root Wads

- Same application as toe wood
- Utilization of felled tree root balls
- Larger diameter of root ball offers increased protection / coverage of stream bank
- Frequently installed with anchors / counterweight stones
- Larger structure than other options

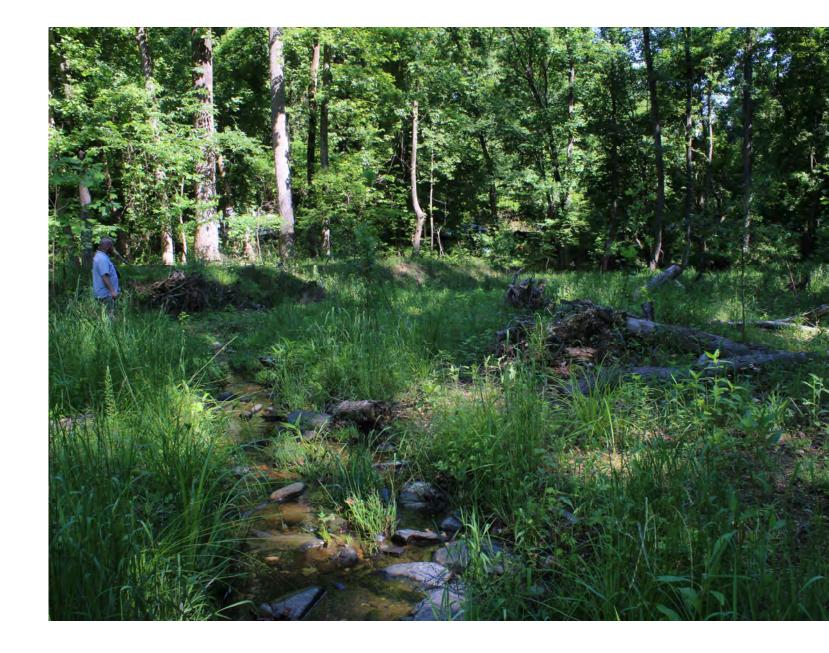
Floodplain roughness features

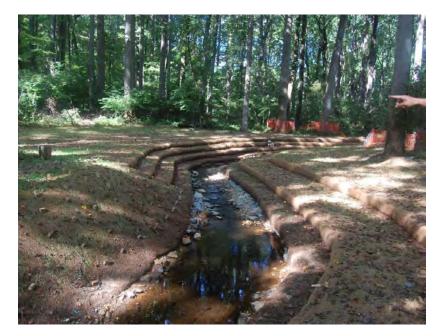
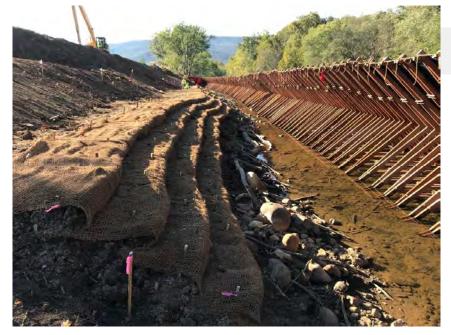
Soil Lifts

- Reconstruction technique commonly used for high erosion / valley wall areas
- Used in conjunction with bioengineering plantings
- Use of wrapped coir materials to provide steeper bank construction
- Use of hardened toe protection in conjunction with soil lifts

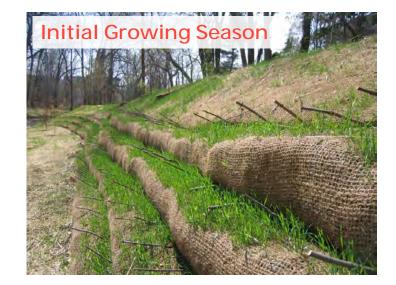
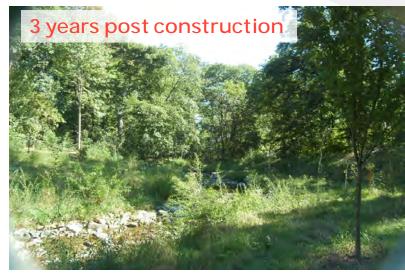
During Construction

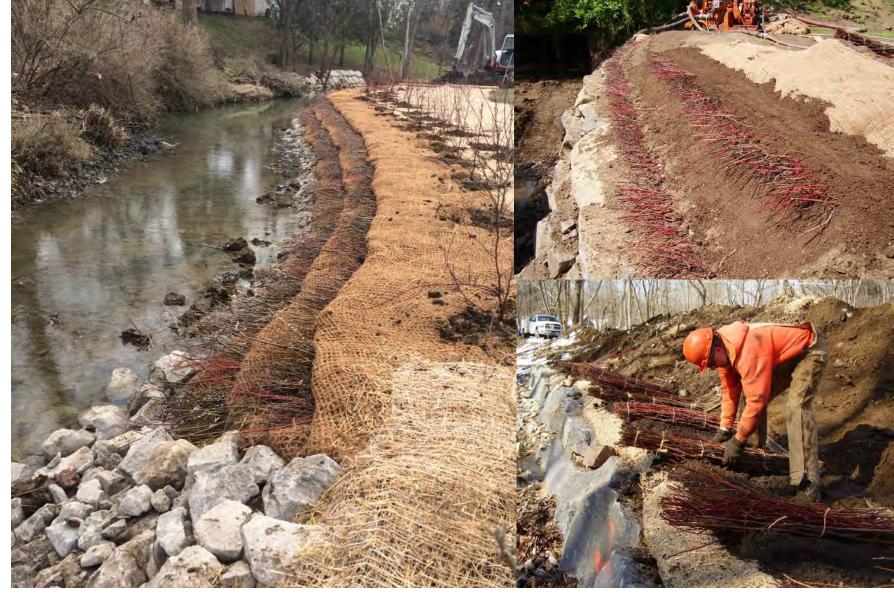
Branch Layering

- Use of native woody plant materials to provide strength and roughness to stream banks
- Common Types:
 - Brush layering
 - Brush mattressing
 - Live fascines/wattles
 - Post and wattle
 - Live stakes
 - Brush box palisade and brush dike
- What not to do
- Keys for success
 - Dormant live material
 - For best survivability the material should be harvested and planted during the dormant season (November 1st April 30th)
 - If material can not be installed when delivered to the site, keep stored in cool, wet and shaded area
 - Typical species include Cephalanthus, Cornus, Salix, Sambucus and Viburnum

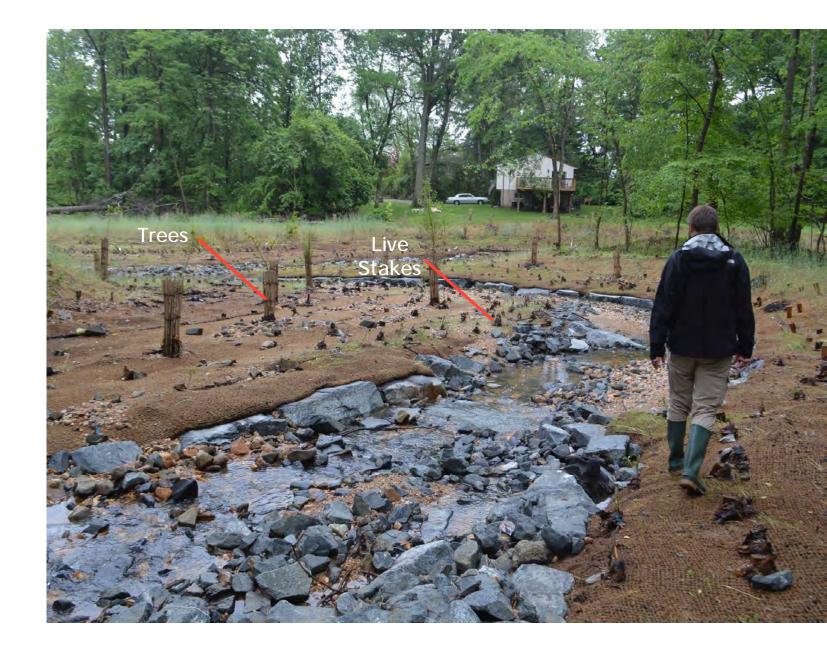
Floodplain bench plantings - live stakes - trees

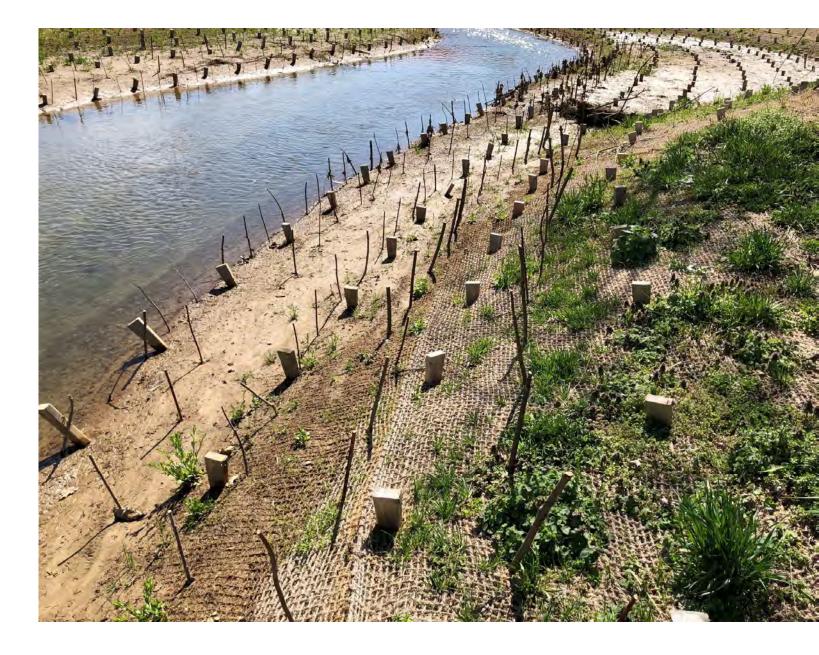
Live Stakes -Post Construction

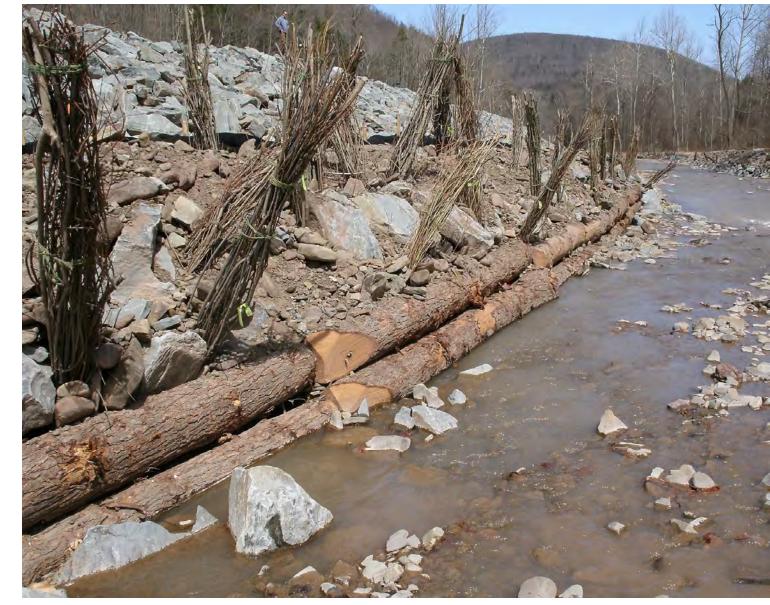
What Not To Do in Bioengineering?

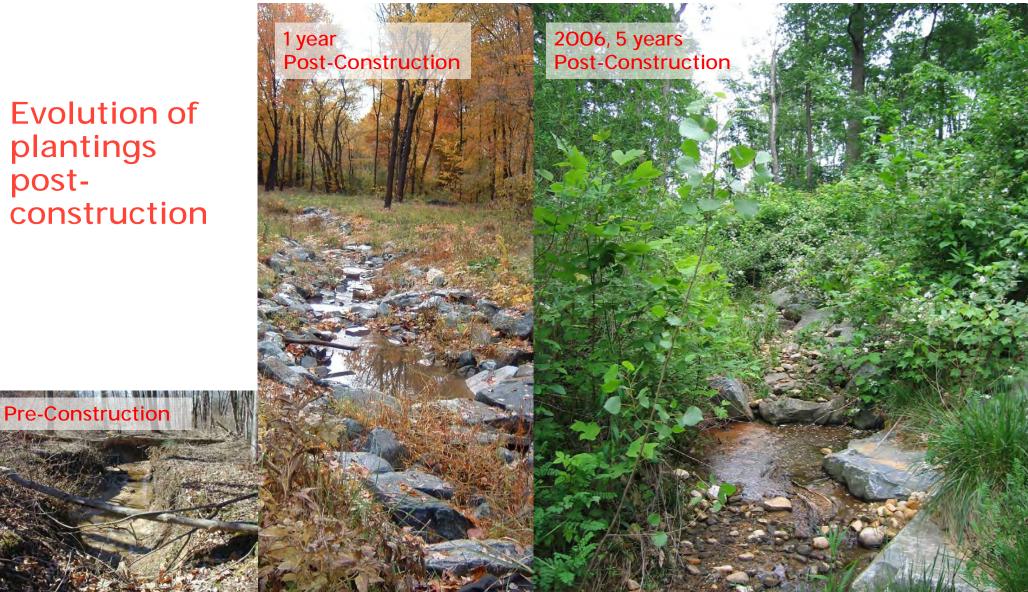
Evolution of plantings postconstruction

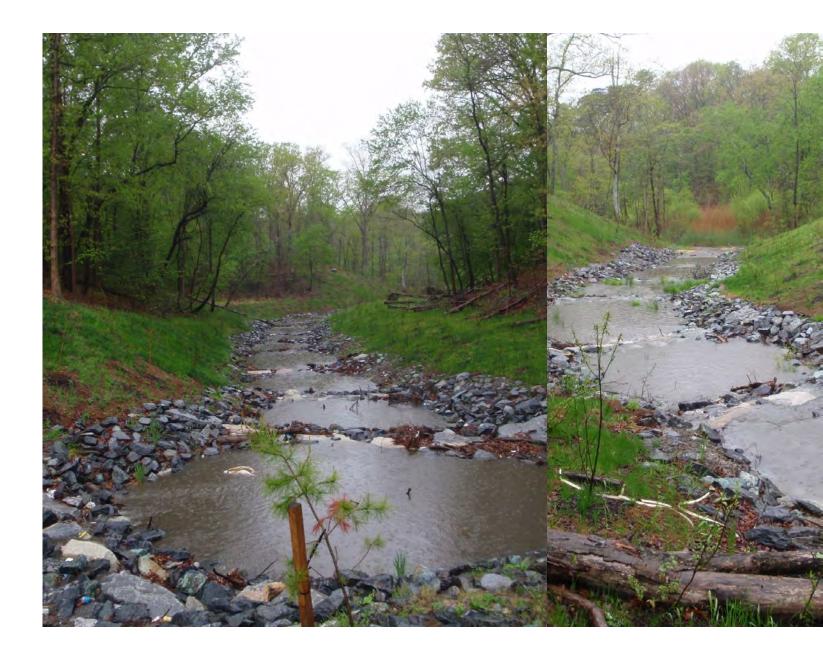
Step Pools

- Good for steep channels
- Often is headwater and 1st order channels
- Can be designed to
 ancourage infiltration
 - Potential to design as RSC or modified RSC to obtain additional water quality treatment credit

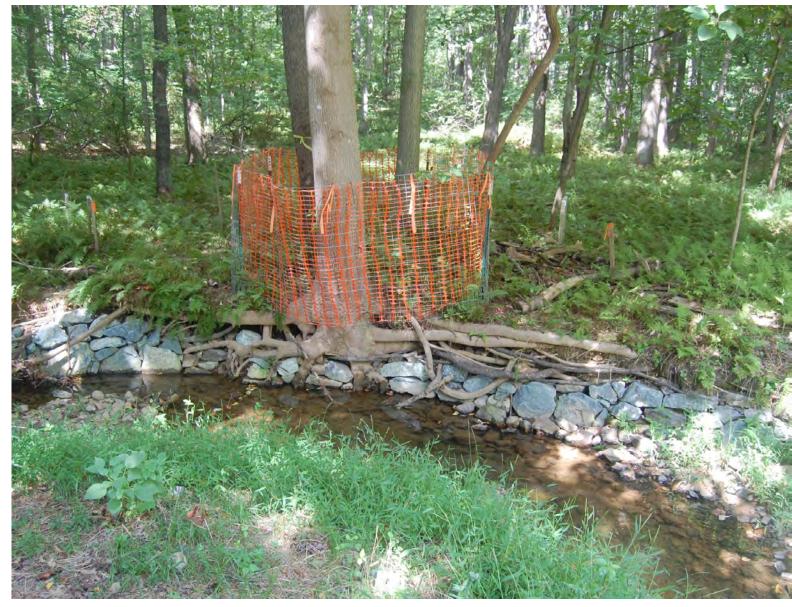
Rock Tree Pack

• Used to stabilize trees on stream banks

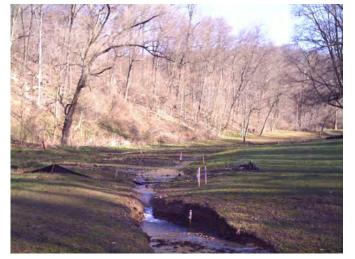
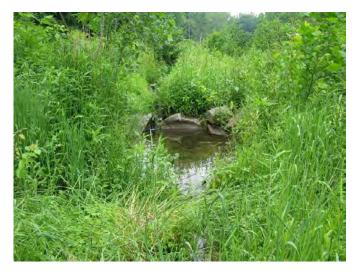
Nine Mile Run Fern Hollow Section

Existing condition

Immediately post-construction

3 years post-construction

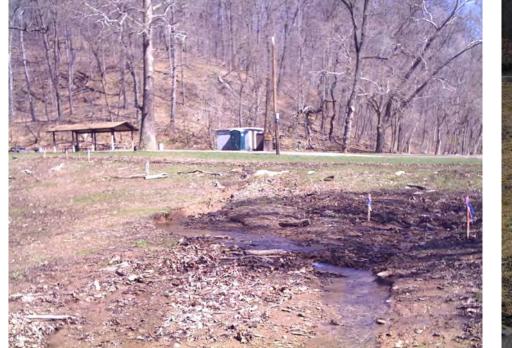
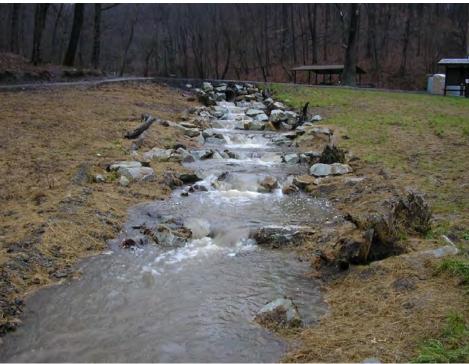
Nine Mile Run Upper Falls Ravine Step

Existing condition

Post-construction

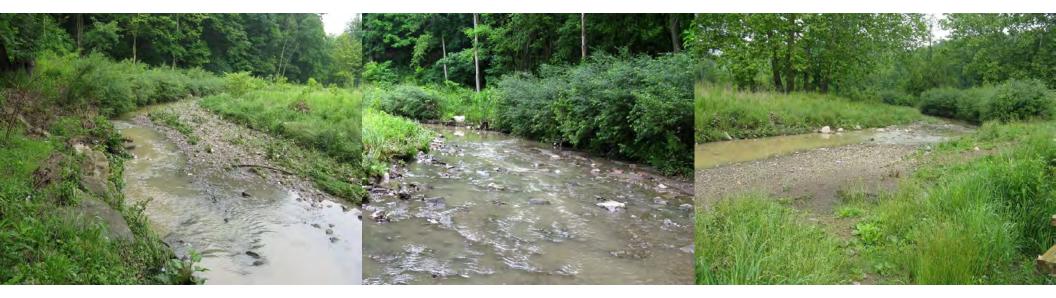
Nine Mile Run Mainstem - 4 years post construction

- ~\$3.3 million construction (2004 to 2006) by MLS
- At the time of construction, this was the largest urban stream restoration project in the country
- 10,400 LF of stream channel. Installed over 40 in-stream structures consisting of vanes, cross vanes, j-hook vanes, step pools constructed out of rock.
