Addressing Green Infrastructure Design Challenges in the Pittsburgh Region

Steep Slopes

January 2014
EPA 800-R-14-002

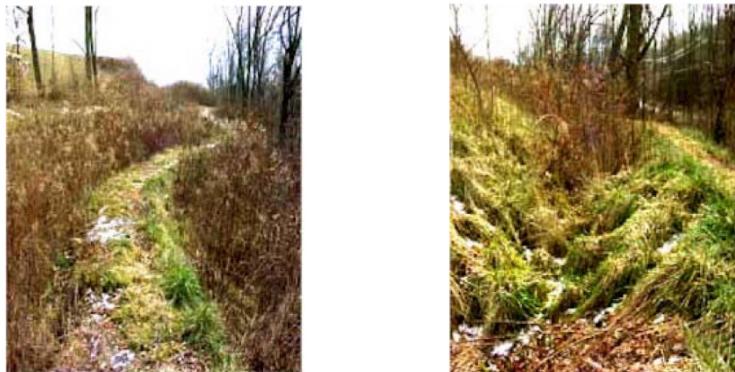
Figure 6. Diversion Berm

Diversion and infiltration berms are one of the few green infrastructure practices that are considered appropriate for construction on steep slopes. A diversion berm is a mound of compacted earth with

sloping sides that is constructed along a contour (Figure 6). Diversion berms are often considered a slope protection practice or a method to revegetate the slope (Pennsylvania SW BMP Manual - BMP 6.4.10). In addition to these goals, berms can be used to promote infiltration in the ditch on the uphill side of the berm (infiltration berm). Care must be taken when infiltrating above structures. Many of the homes and buildings in the Pittsburgh area are structurally vulnerable to wet soil conditions.

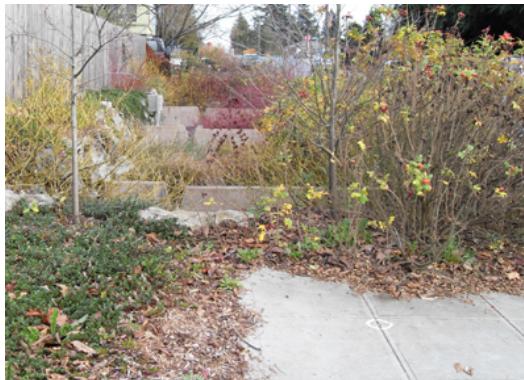
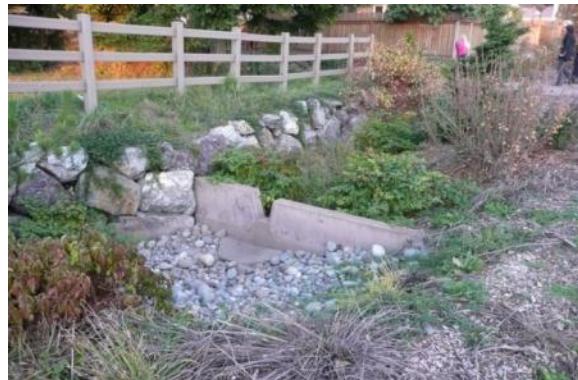
Figure 9. Seattle 110th Street Cascade Project

NW 110th Street Natural Drainage System Project, is an example of constructing a bioretention practice on a moderately steep slope. Refer to row 1 of Table 2. Seattle Public Utilities built their second stormwater cascade during 2002 and 2003 along NW 110th Street between Greenwood Avenue N and 3rd Avenue NW. In Seattle, a cascade is a roadside bioswale using a series of stepped pools on a sloped road. Refer to Figure 9 showing the 110th Street cascade, which is on a residential street with a slope of nearly 6 percent over a 53-foot vertical drop.

The cascade utilizes a series of 12 stepped-pool bioretention cells separated by concrete V-notch weirs along one side of the street. The total length is 900 horizontal feet. The existing soil was somewhat sandy weathered till and was amended with compost to promote infiltration. Figure 10, Figure 11, and Figure 12 show design details for the project. The weirs, vegetation, and rock berms help decrease the velocity of the water. The complete construction plan can be found at the following web address:
<http://www.seattle.gov/util/MyServices/DrainageSewer/Projects/GreenStormwaterInfrastructure/CompletedGSIProjects/110thCascadeProject/index.htm>

The 110th Street cascade was able to completely retain 186 (79 percent) of the 235 precipitation events recorded, and is able to completely attenuate surface runoff from about 0.3 inches of rain under any condition. These numbers are an improvement from the performance of the Viewlands cascade, which retained about 27 percent of precipitation events with no discharge and fully attenuated surface runoff from about 0.13 inches of rainfall. The main design enhancement likely contributing to the improvement was amending the soils in the 110th Street cascade. Other significant results include the following:

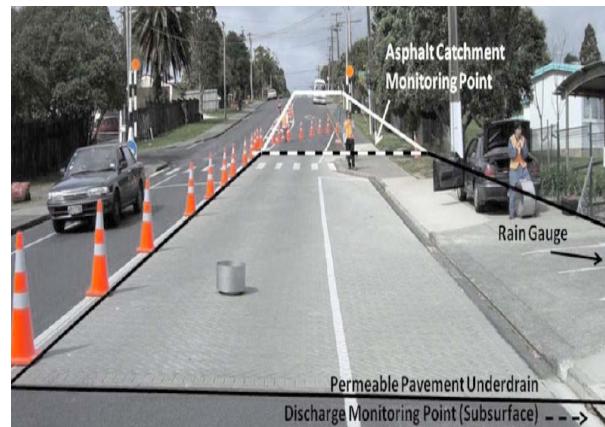
Figure 13. Permeable Concrete Paver Block Test Site

In 2006, a permeable modular concrete paver test site was constructed on an active roadway with an atypically high slope of 6-7.4%. The test site also included an adjacent conventional asphalt catchment for concurrent monitoring with the permeable modular pavement (PMP). Flow monitoring was conducted between 2006 and 2008 to assess the effectiveness of the site in reducing stormwater volume and peak flow rate.

The 2,100-square foot PMP site is constructed of impermeable concrete paver blocks with enlarged joint spacing such that the peak flow from the 2-year 24-hr storm event can pass through the aggregate-filled joints. Beneath the paver blocks is a bedding layer. An approximate 18-inch base course thickness is installed below the bedding layer. The base course is made up of a layer of 0.5-inch aggregate over 1.5-inch aggregate. Water that percolates to the base course discharges through an underdrain at the downstream end of the test section or infiltrates to groundwater. Soil testing conducted before construction characterized the subgrade soils as silty clay and clayey silt with little to no permeability.

Over the monitoring period, the hydrologic performance of the PMP was better than expected and compared favorably to modeled predevelopment conditions. Predevelopment conditions were maintained for runoff lag time, peak flow, and duration of flow.
